Airfoil Journal Bearing – The Road to a Million Start Stops

ABSTRACT

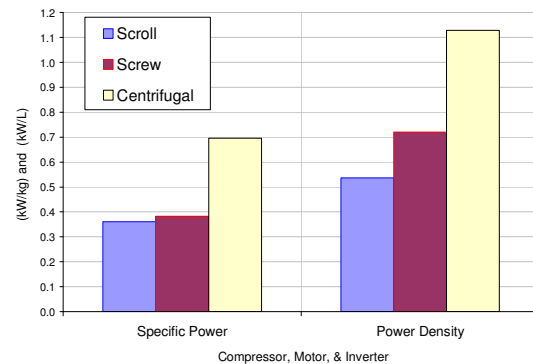
Figure 1. Specific Power (kW/kg) and Power Density (kW/L) for candidate compressor technologies, taken at 2.5 PR and 325kg/hr air flow

Even with the advances in hydrogen technology in the last decade, there are still many challenges to overcome before fuel cell vehicles can compete in the market with current vehicle technology. The cost and durability of the fuel cell system are the most significant challenges. In order to make the electronic supercharger (ESC) in the fuel cell commercially viable, a direct coupled centrifugal device provides the smallest (for both mass and volume) device at the lowest cost. The power density and specific power comparisons for three viable compressor technologies are shown in Figure 1, and include the power electronics necessary for driving the compressor. For the centrifugal technology, power density (power per unit volume) is 1.13 kW/L,

while specific power (power per unit mass) is 0.7 kW/kg. This performance meets US Department of Energy targets for the automotive fuel cell air cathode compressor [1]. However, to achieve this superior performance, the centrifugal impeller must spin upwards of 100,000 rpm in order to efficiently produce 2.5 bar pressure at 325 kg/hr airflow. At these speeds, bearing design is challenging.

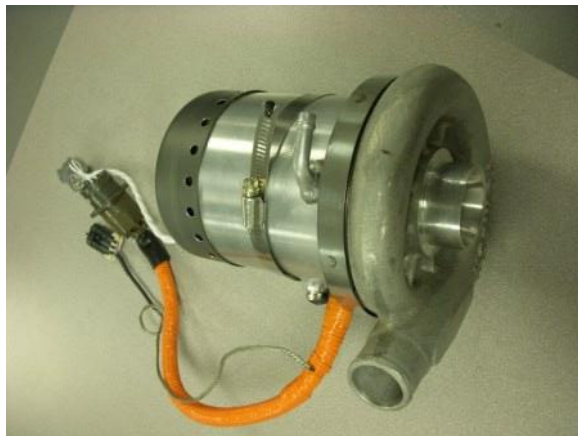
Figure 2. Electronic Supercharger (ESC), Integral Motor/Compressor System

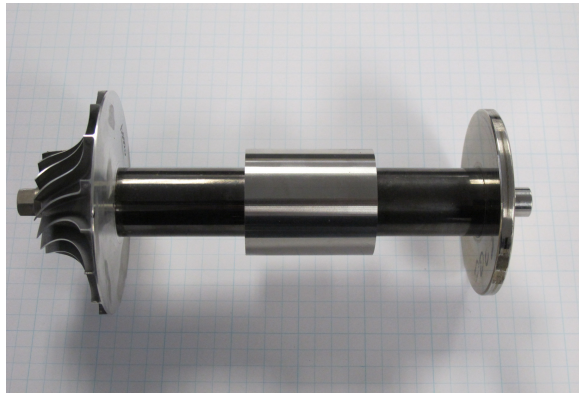
Figure 4. Assembled ESC Rotor System showing impeller (Left), fore/aft bearing journals, PM rotor, and thrust disk (Right).

A cross sectional schematic of an airfoil bearing is shown in Figure 3. The right side of the figure shows generally the different parts of the bearing used in this study – top foil, bump foil, rotating journal, location of PTFE coating, and retention key. The bearings used in this study are considered “GEN-II”, meaning, they employ a segmented bump foil which bears in the housing bore, and supports a pair of foils, the first top foil being prepared with the PTFE-based coating [9] [10]. Details of the bearings and other system parameters are summarized in Table 1. The rotor system of the ESC is depicted in Figure 4.

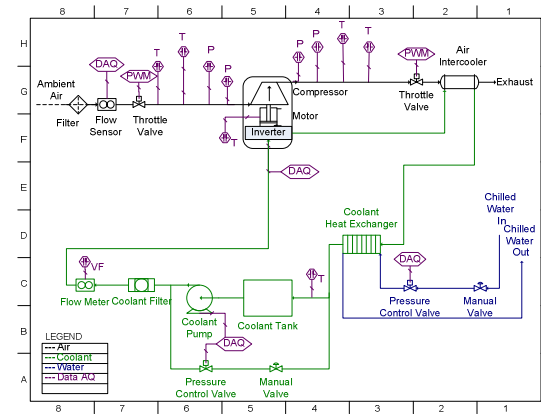
As shown in Figure 5, the test stand is plumbed according to SAE standards [11]. Two pressure sensors clocked 90 degrees and 75mm apart are installed on the inlet and outlet pipes of the air compressor. Two temperature sensors clocked 90 degrees and 75mm apart are also installed on the inlet and outlet pipes of the air compressor. The approximately 75mm pipe diameter is chosen on both inlet and outlet pipes so stagnation conditions are measured (flow velocity contribution of dynamic pressure is minimal). Also according to [11], the transition from 75mm diameter ducting to the inlet and outlet of the compressor is within an effective length of 1.5 x diameters. And sensors are located at least 150mm away from the transitions.

Figure 5. Process diagram/schematic of test stand setup and operation

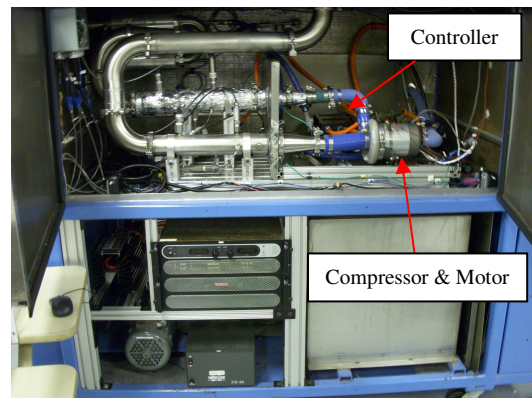
Figure 6. Test stand front view

The test stand is shown pictorially in Figure 6. The compressor is placed inside an enclosed test chamber for safety. The compressor and motor are shown on the right, inside the test chamber, with the black

controller module (inverter) directly behind it. The large stainless steel box below the compressor is the water ethylene glycol mixture reservoir (for cooling of the controller / motor). Next to the reservoir is the high voltage DC power supply. A power supply converts 480VAC from the wall to 325V DC supply for the electronic supercharger. Next to the power supply (on left) is a large diode to prevent damage to the power supply from any potential reversals. Below the power supply is the coolant pump. Test stand software enabled the automatic running of a test profile (24 hours, 7 days, 52 weeks) as long as 480VAC power is provided. A PC-based controller and data acquisition system controls the actuators and records the data.

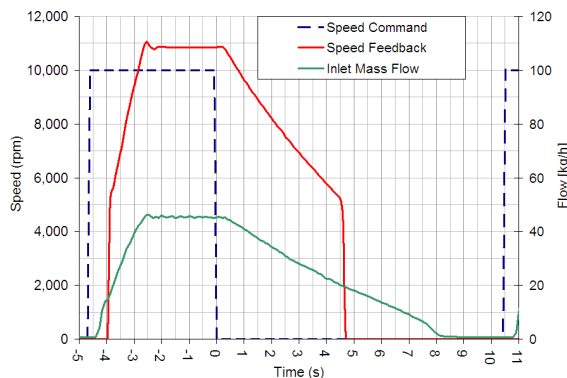
Figure 7. 15s Start Stop profile

A 15s repetitive cycle is defined. An up transient (followed by a down transient) are used to “wear” the bearings. Referring to Figure 7, the speed command is shown in blue, the speed feedback in red, and the inlet air mass flow in green. Inspecting the figure, at time -4.5s, the rotor is stopped and the speed is at 0 rpm. An up transient step function then occurs, with a speed command of 10,000 rpm which is held between [-4.5, 0]s. Now the down transient is lined up with 0s in the figure. From [0, 10.5]s the speed is commanded to 0rpm. During these tests, the resolver could not properly detect speeds below 5000rpm. Therefore, in order to ensure the rotor has fully come to rest, system air mass flow is also used as an indication (but not as a determination of lift-off speed). This testing is conducted as part of a rotor assembly in a fully functioning electronic supercharger (motor and compressor assembly with controller). It is not meant to just validate the bearings, but the bearings in a production assembled product environment.

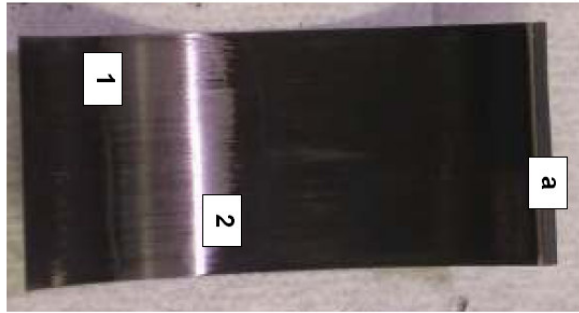
As mentioned earlier, a baseline bearing system validated the test protocol. It is important to confirm that the test cycle is stressing the known failure mode. Referring to Figure 8, the baseline system after 50,000 start-stops shows the top foil has experienced substantial wear-through of the PTFE coating. The foil in this region is now experiencing metal-to-metal contact during start-stop operation. Here "a" indicates the foil retaining tab, "1" indicates where the rotor touches down on a stop (consistently the same angle) and "2" indicates where the rotor lifts off during a start (feathering as the location changes and the journal rotating axis shifts). Although the machine can still start up and function, continued start-stop events will inevitably lead to highly accelerated wear of both the foil and mating journal, and rapid wear-out of the entire system. Having accomplished only 1/20th the desired start-stop life, the baseline system does not meet requirements.

Figure 8. Top foil, baseline system, after 50k start-stops

Therefore the 15 second profile shows the bearing cycling has truly worn through the PTFE coating, exposing the base metal. So, after 50,000 start-stops, the top foil is considered to be at the end of life. This validates the test cycle.

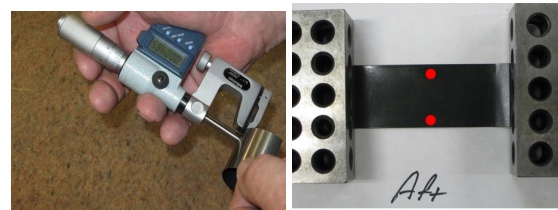
measurements are conducted at a consistent, stabilized 21°C ambient. Selection of the measurement location is shown in Figure 9 at the red dots, with two middle location points chosen. Baseline bearing testing indicated this location is at or near the area of most wear. By measuring at the top and bottom edges, any tilt in the rotor assembly during lift off and touch down is accounted for. Additional locations are also measured, however those results do not provide any significantly different wear trends, i.e., results were at or less than the severity of wear found in the middle, so are not presented.

Figure 9. Top Foil overall thickness measurement (left) and measurement locations (right)

A handheld digital Precision Micrometer is used to measure total thickness of the top foil. The tool has a resolution of $1\mu\text{m}$ [.00005in]. Bearing inspection is conducted by three operators at each inspection, with each taking a minimum of three measurements.¹ All

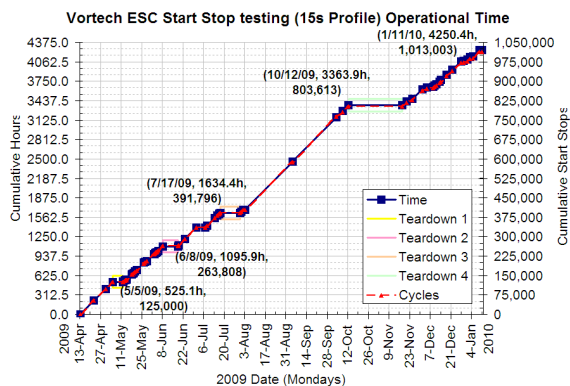
This improved design is run for 1,013,000 start-stops. The run chart in Figure 12 shows the cumulative test duration conducted over almost 9 months. The test encompassed a total 4,250 hours of operational time. Every 625 hours equals 150,000 start-stops based on a 15s profile. As can be seen in the plot, the start stop cycles and the run time are line on line.

Figure 12. Start-stop run chart

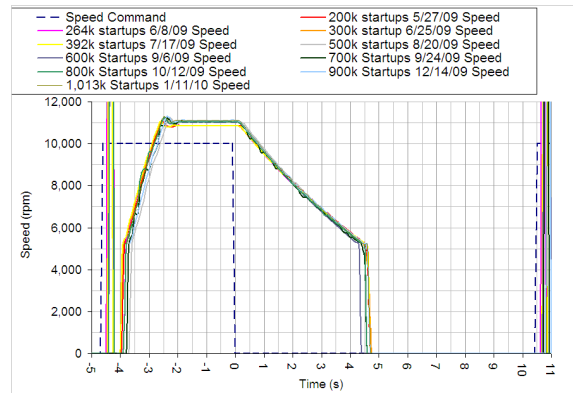
Examining the speed feedback in Figure 14, the rotor speed consistently achieves 11,000 rpm. The spike

which occurs when the speed is first commanded from 0 to 10krpm is the result of electromagnetic interference (noise creating a false reading). The recording device thinks there is a Pulse Width Modulation signal at 100% duty cycle. This is from the start-up strategy to begin rotating the motor without knowing the actual position of the rotor – there is larger electromagnetic interference until the rotor begins rotating in synch with the stator phases.

Figure 13. 15s start-stop profile; speed

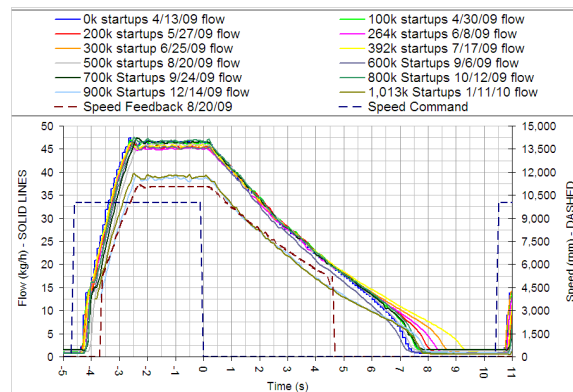
The corresponding mass flow is plotted in Figure 14. There is a change in the idle flow after 800,000 start ups. This is because the mass flow sensors have been switched and a calibration offset of 10kg/h appears with the new sensors. The change in flow is the important measurement here, so a complete stop of the rotor can be detected.

Figure 14. 15s Start-stop profile; air mass flow

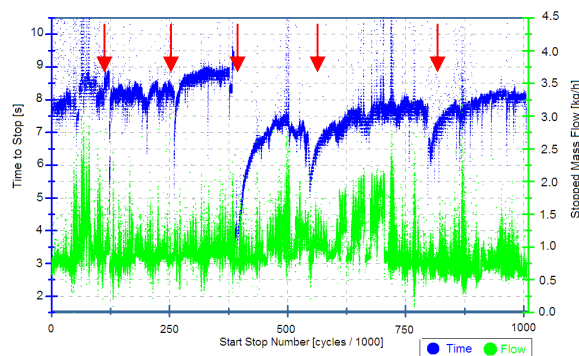
Figure 15. Stop time and flow by Run

Analysis of the post processed data shows there are no trends to indicate degradation over time. The data does show a slight dip in running average after the 392k teardown for stop time. Referring to Figure 15, because of this noted shift of the running average seen at 392k in the stop time, the decision is made to run cycling from 392k to 800k before a fourth teardown. In fact, between the 404k and 800k segment, there are two continuous blocks of 180k

cycles (as well as two 20k blocks). Pauses in the cycling are caused by a memory cache fault which lasts less than 2 minutes. For example, there is an interruption roughly at 550k start-stops (i.e. see the sudden dip towards 0 kg/h on stop time graph in Figure 15).

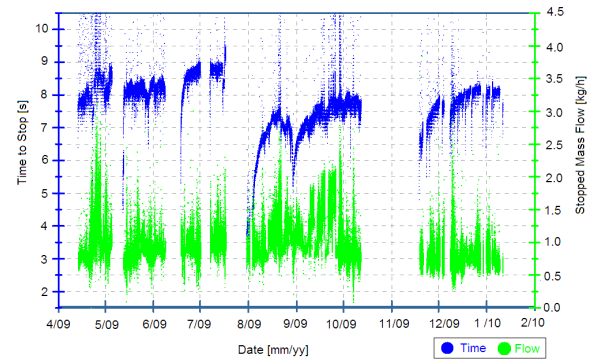
intervals.² From this data, processed terms are collected for each validated start-stop recorded. This is important to track and show the bearings had actually lifted off and touched down 1,013,000 times. There is less than a 1% start-stop difference between data acquisition recorded events and actual commanded cycles. This is the reason the bearings are run for 1.3% margin over 1 million start-stops. Examining the processed data, there are some interesting effects in the stop time. Stop time is defined as the time to 95% decay – or when the air mass flow first records less than 2kg/h. The mass flow is selected as the trigger since speed feedback is only resolvable above 5,000rpm. The “stop” mass flow is the average mass flow during the last 1s of the OFF time in the profile. It should be noted that the mass airflow sensor used has a minimum value which is approximately 0.8 kg/h. As shown in Figure 15, the stop time is affected by stopping the test for a period of time. Each spike down towards 0 seconds is the performance after the unit had either been torn down or testing is temporarily interrupted for other reasons (loss of power, test stand work, revisions to control software, etc.). These spikes are indicated by a red arrow. The interruptions are clearly seen in Figure 16, where the post processed data is graphed by date.

Figure 16. Stop time and flow by Date

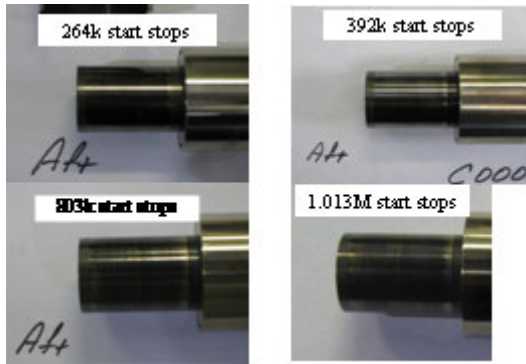
The measurement results are shown in Table 2, pictures of the airfoils are shown in Figure 17, and pictures of the journals in Figure 18. Reflections are circled in red on the pictures; all bearings remained completely coated with PTFE and are black in color

Figure 18. Aft Journal, Progressive Wear

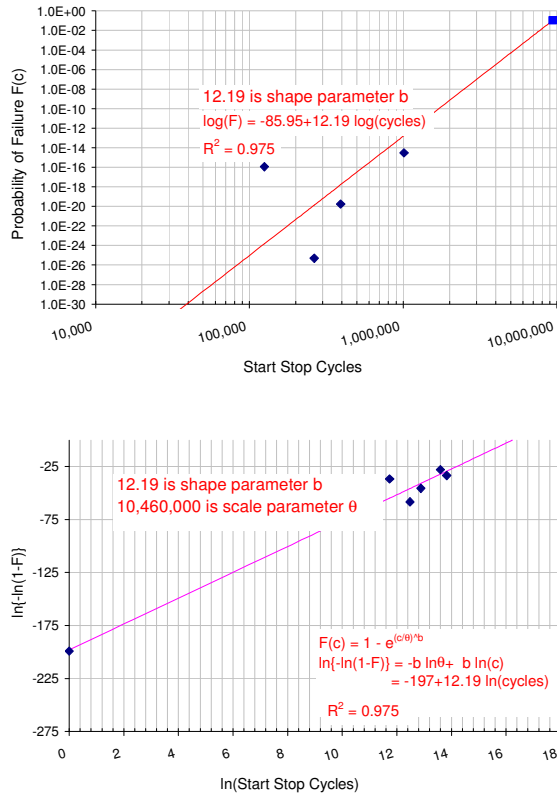
Figure 19. Cumulative Failure Distribution - Approx (top) and Exact (bottom)

shows the derivation of the shape and scale parameters for the cumulative failure distribution. This results in Eq. (3).

$$F(\text{cycles}) = 1 - e^{-\left(\frac{\text{cycles}}{10,460,000}\right)^{12.19}} \quad (3)$$

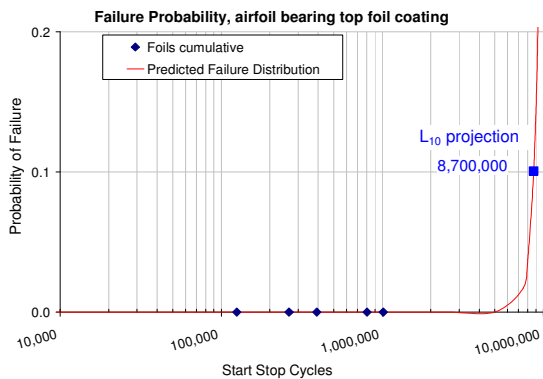
Figure 20. Failure distribution plot and predicted life

Figure 20 depicts a probability plot (Weibull) of the predicted top foil life, in number of start-stop cycles. This assumes a wear/loss of $2/3^{\text{rd}}$ of the top foil PTFE coating. The L_{10} value is 8.7 million start-stops.
